NATIONAL BUREAU OF STANDARDS

CIRCULAR OF THE BUREAU OF STANDARDS C450

UNDERGROUND CORROSION

By Kirk H. Logan

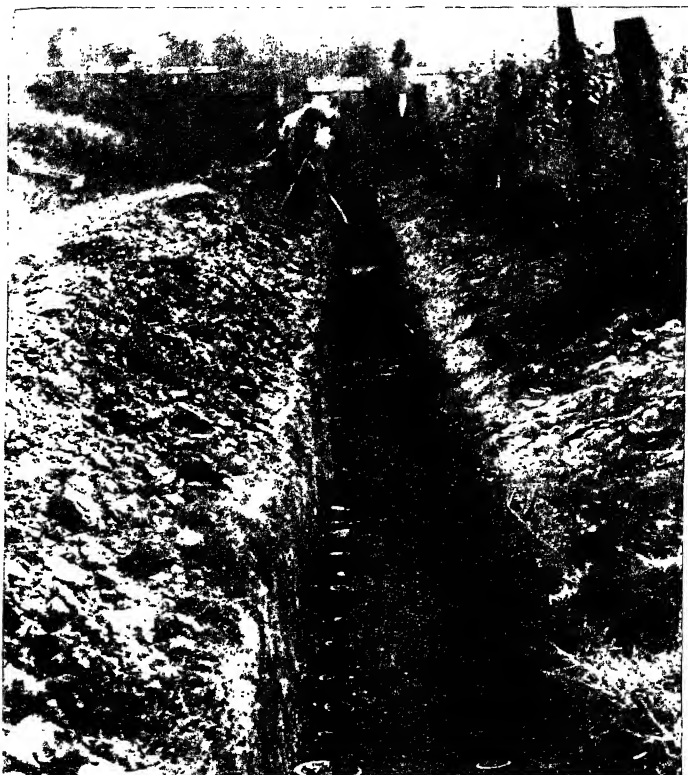
FIGURE 4.—Burial of soil corrosion specimens near Alexandria, Va., in 1922.

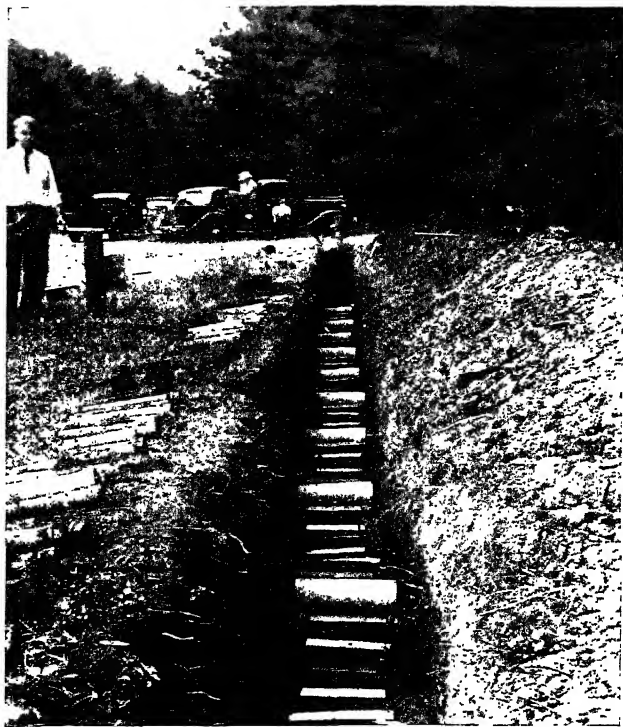
FIGURE 6.—Arrangement of specimens buried near Baltimore, Md., in 1932.

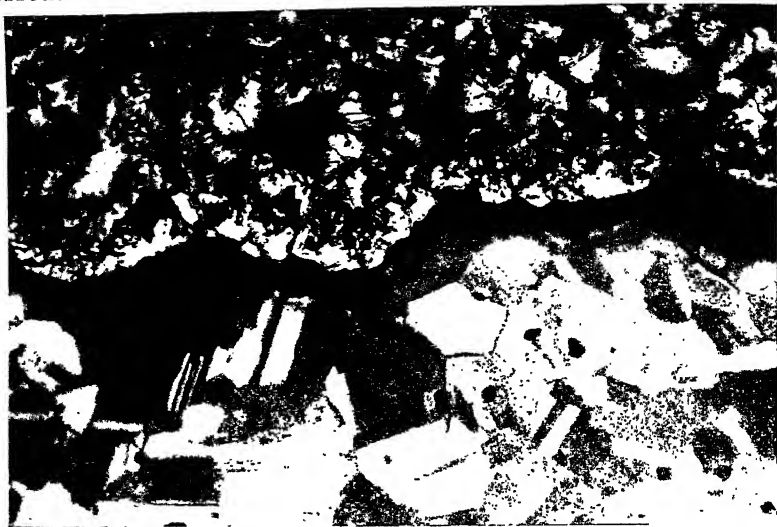
FIGURE 24.—Yellow brass exposed 9.53 years to Sharkey clay. Transverse section showing uncorroded metal (below) and dezincified metal (above) $\times 500$.

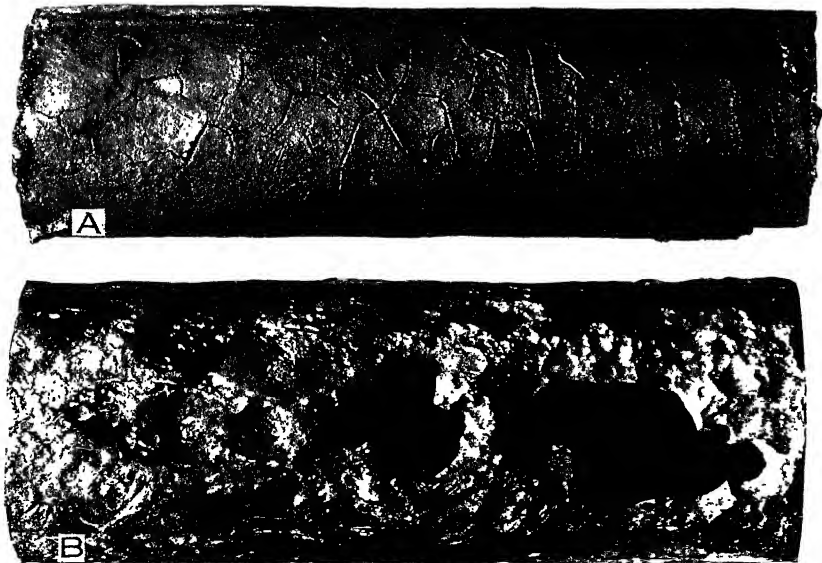
FIGURE 76.—Examples of failure of pipe coatings.
